## Significant Incident Summary No. 3

### Installing non-original sun visors that reduce field of view – fatal incident

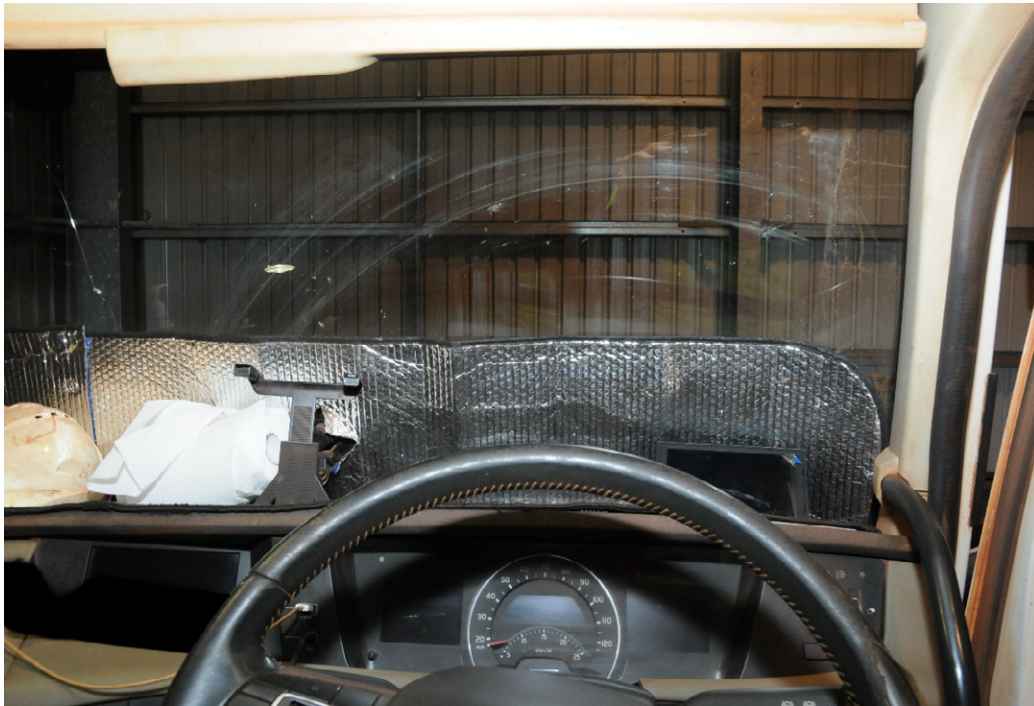
View from cab of truck with non-original sun visor fitted.

- The sun visor may have further restricted the view of the driver so that the worker was unseen when the vehicle moved off.
- The person conducting a business or undertaking (PCBU), including persons having control of the workplace, not identifying the potential hazards associated with the installation of non-original sun visors in the windscreen of trucks.

- Educate workers of the potential dangers from installing non-original items to vehicles that may restrict the field of view and increase the size of blind spots.
- Conduct regular checks of the cab to ensure non-original items have not been added to a vehicle that may restrict the field of view of the driver.
- Encourage workers conducting maintenance on vehicles to alert the PCBU to the presence of such items when completing routine maintenance.
- Remind drivers to conduct a pre-start check before setting off to ensure as far as practicable that no persons are in the vicinity of their intended direction of travel.
