Significant Incident Summary No. 11

All-terrain elevating work platform (EWP) incident

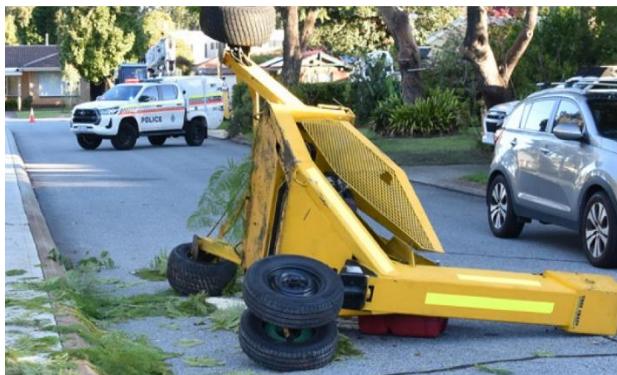
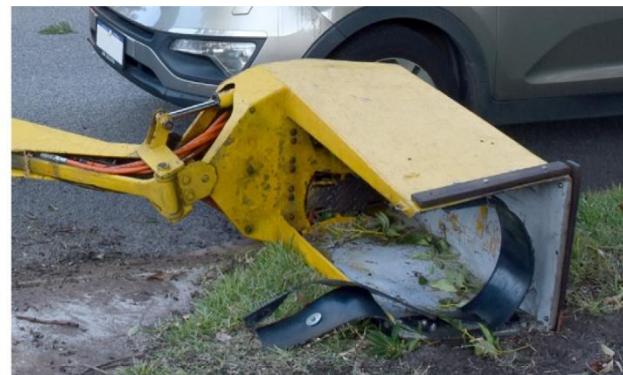
The worker was operating the EWP from within the basket. While manoeuvring around the tree canopy with the boom fully extended, the dual front wheel of the EWP veered off the kerb and onto the road surface. The resulting instability caused the EWP to tip over onto its left side.

The basket containing the worker fell approximately six metres, struck a parked vehicle, and landed on a verge across the road. The worker sustained spinal injuries and multiple fractures.

- workers were not provided with adequate instruction and sufficient information in accordance with the manufacturer's operating manual
- the wheelbase of the EWP was not fully extended due to incorrect setup, compromising its stability
- the ground slope limits were not assessed prior to commencing work
- insufficient water ballast may have increased the risk of the EWP tipping.

- EWPs are operated on level and stable ground with the drive wheel in the fully extended position so the basket can be safely elevated to its maximum height

- EWPs are fitted with slope indicators and the slope limit of the ground is measured prior to operation to ensure the manufacturer's maximum safe gradient is not exceeded

- EWPs are operated in slow mode when manoeuvring around tree canopies, when the boom is extended to more than a quarter of its maximum height, and when the EWP is being driven within half of its maximum slope capacity
