Significant Incident Summary No. 11

All-terrain elevating work platform (EWP) incident

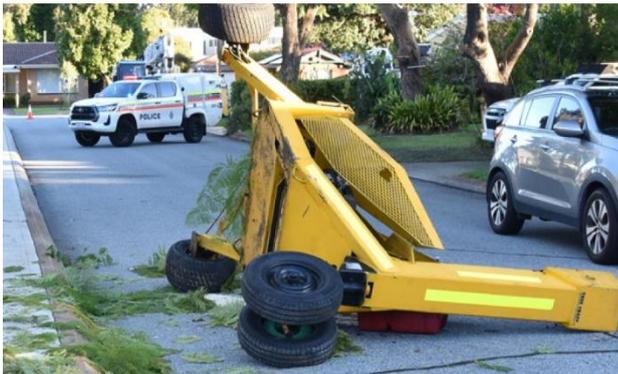
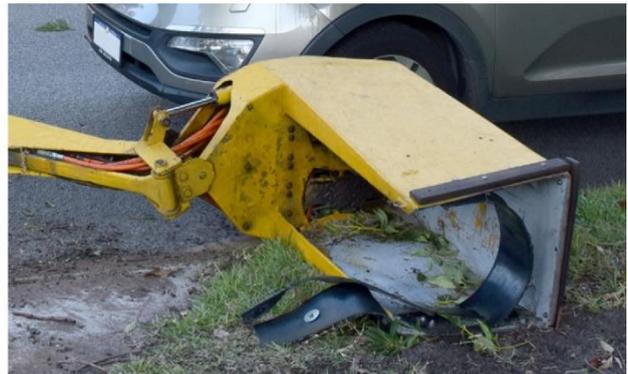
The worker was operating the EWP from within the basket. While manoeuvring around the tree canopy with the boom fully extended, the dual front wheel of the EWP veered off the kerb and onto the road surface. The resulting instability caused the EWP to tip over onto its left side.

The basket containing the worker fell approximately six metres, struck a parked vehicle, and landed on a verge across the road. The worker sustained spinal injuries and multiple fractures.

- workers were not provided with adequate instruction and sufficient information in accordance with the manufacturer's operating manual
- the wheelbase of the EWP was not fully extended due to incorrect setup, compromising its stability
- the ground slope limits were not assessed prior to commencing work
- insufficient water ballast may have increased the risk of the EWP tipping.

- operators conduct pre-operational checks using manufacturer-supplied checklists or manuals, including checks to ensure the safe working load of the basket is not exceeded

- operators have completed an EWP training course delivered by a registered training organisation
- EWPs are operated on level and stable ground with the drive wheel in the fully extended position so the basket can be safely elevated to its maximum height

- EWPs are fitted with slope indicators and the slope limit of the ground is measured prior to operation to ensure the manufacturer's maximum safe gradient is not exceeded

- EWPs are operated in slow mode when manoeuvring around tree canopies, when the boom is extended to more than a quarter of its maximum height, and when the EWP is being driven within half of its maximum slope capacity
